Structure Number: 62
Original Use: Housekeeping Quarters
Present Use: Personnel Quarters (duplex – north unit occupied, south unit unoccupied)
Construction Date: 1922
Architect: Unknown
Number of Levels: Four Levels (Including Basement and Attic)
Total Area: 7,316 square feet
Plan Shape: Rectangular
Basic Construction: Wood framing
Uses per Floor:
First Floor –
Living Room, Dining Room, Kitchen, Pantry off Kitchen, 1 Closet, 2 Stairs back to back

Building 62

Structural Maintenance and Treatment Plan - Exterior Quarters

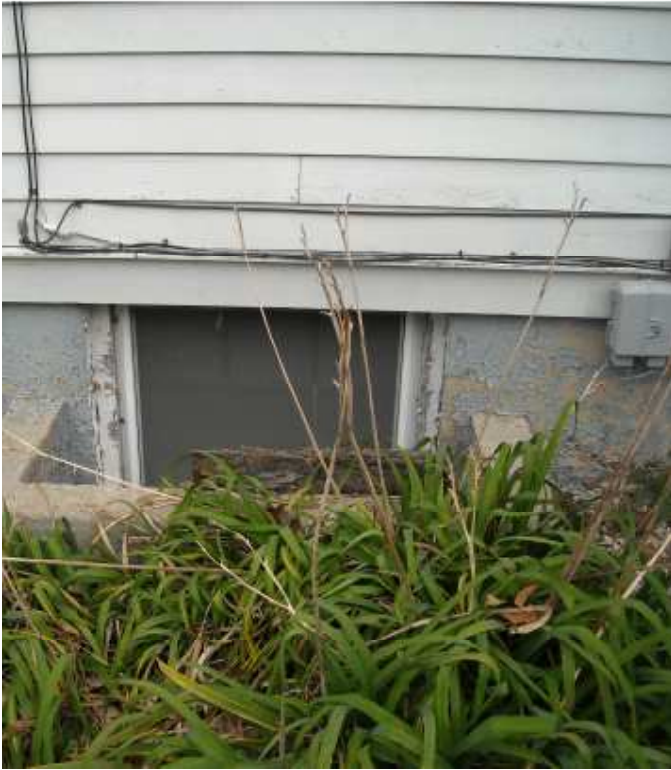
1 *Peeling paint at concrete foundation and wood windows.*

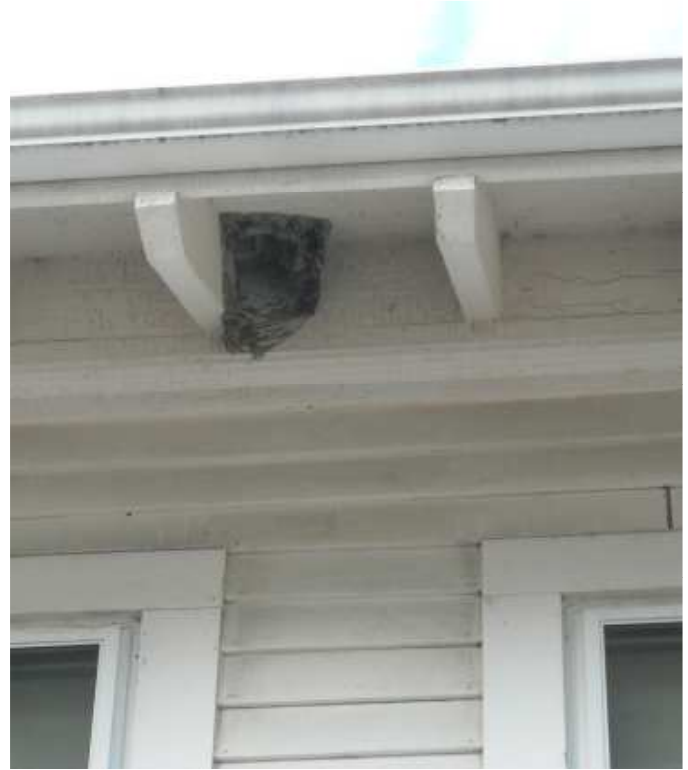
2 *Dirt build-up on wood siding; peeling paint at soffits and fascia.*

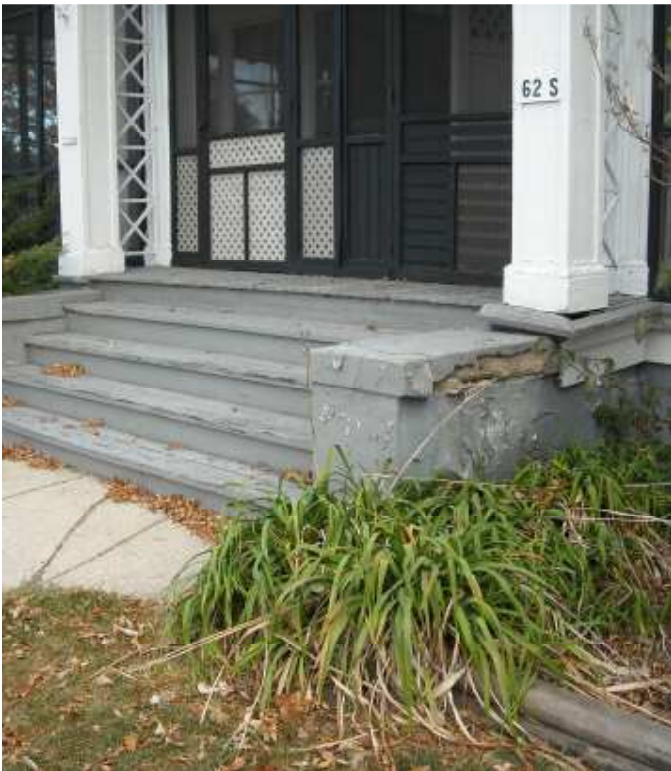
3 *Damaged concrete trim; advanced structural deterioration at wood porch.*

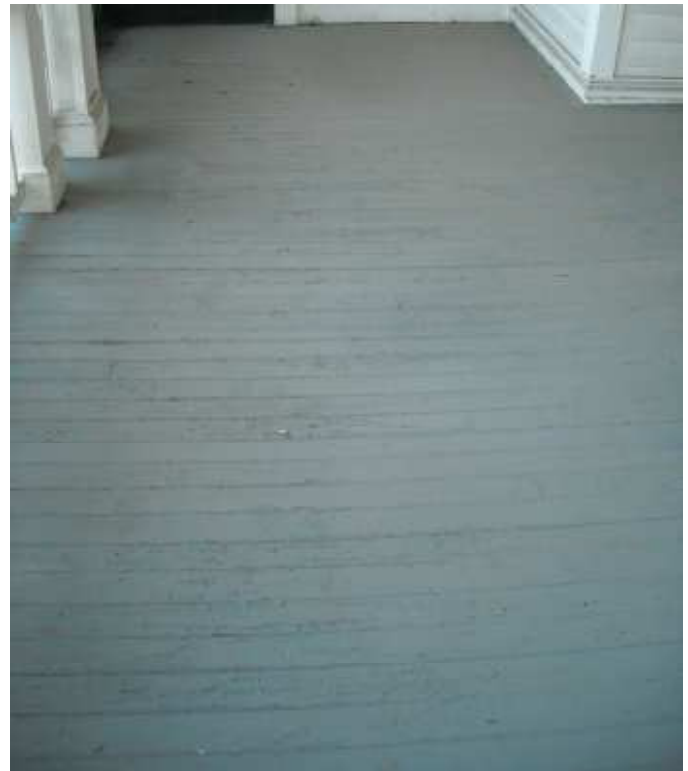
4 *Peeling paint at wood porch.*

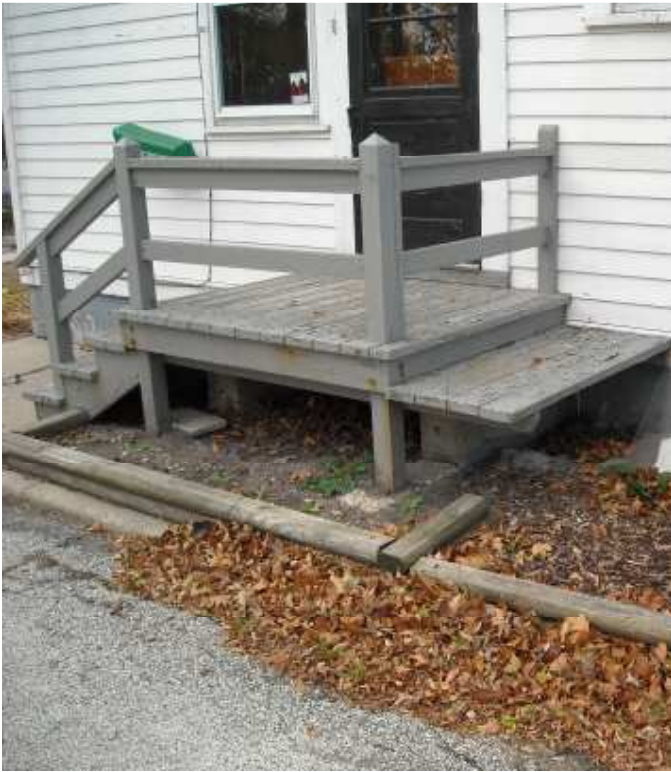
5 Peeling paint at wood porch.

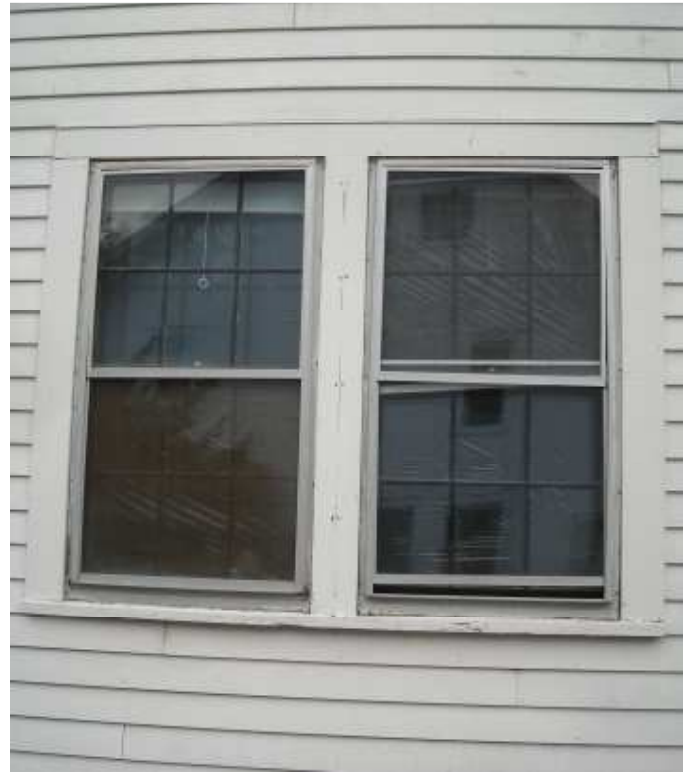
6 Inappropriate aluminum storm windows; deteriorating caulk.

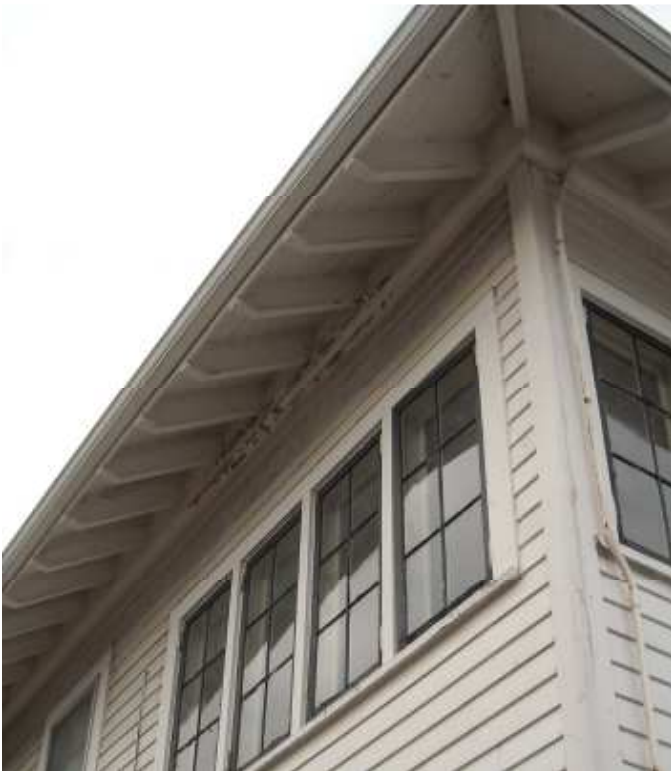
7 Peeling paint at soffits and fascia.

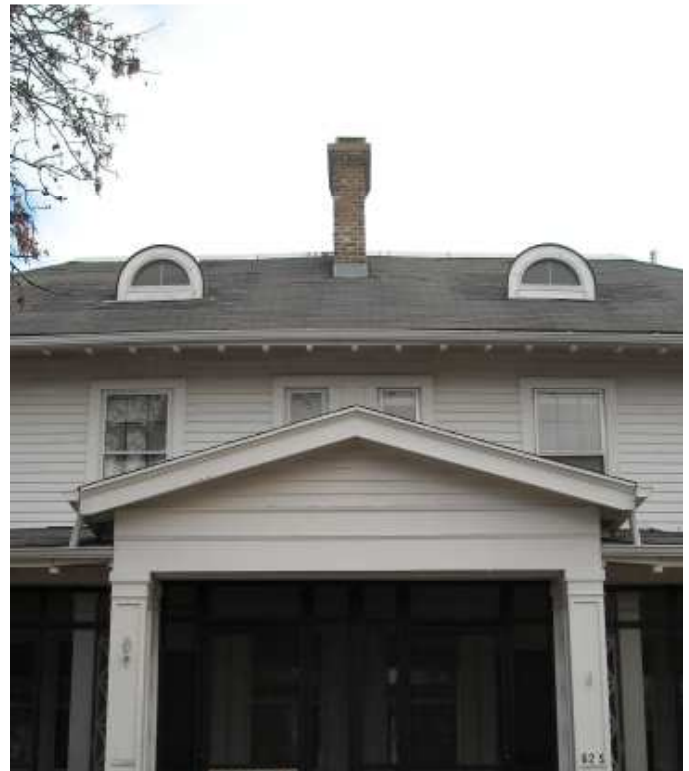
8 Sagging ridge.

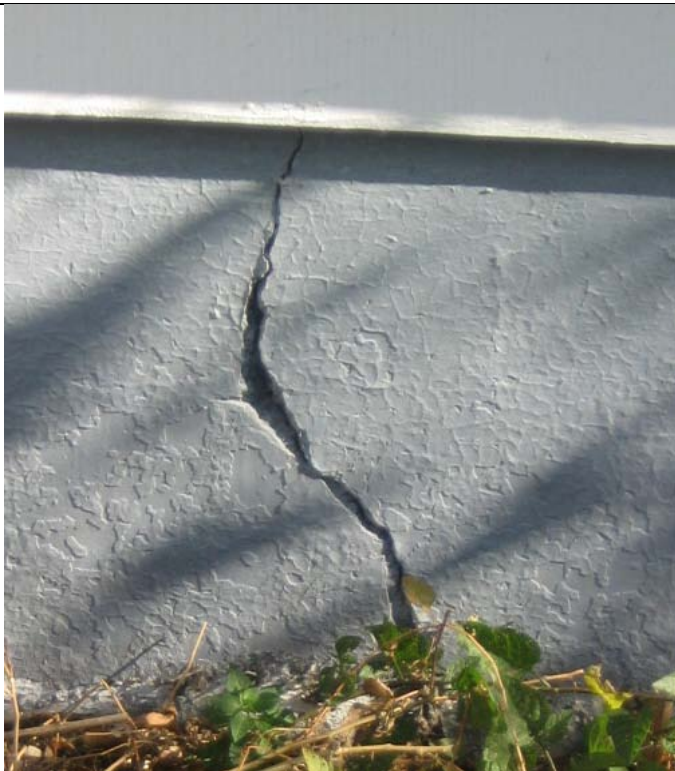
Minor cracking and surface deterioration is present on both the exterior & interior faces of the foundation walls. There was also minor structural deterioration found for many of the interior masonry piers. More significant cracking and surface deterioration was at the foundation walls at the (1) exterior patio location.

Photo 1: Deterioration & Cracking at Existing Concrete Foundation Walls.

Repair of all existing concrete foundation walls where cracking and deterioration has occurred should be addressed in the near future. Cleaning & removal of the surface deterioration that is currently present would also be recommended.

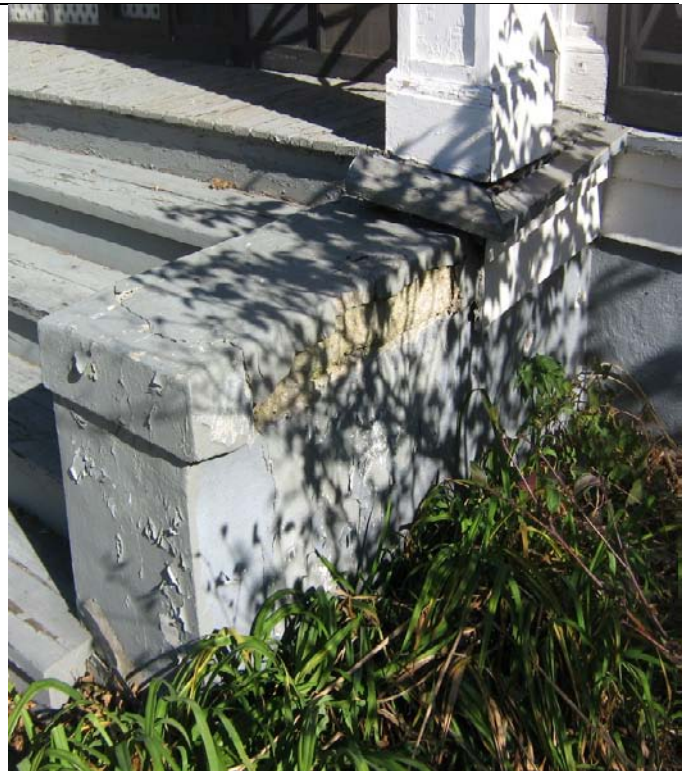
Photo 2: Deterioration & Cracking at Existing Concrete Foundation Walls.

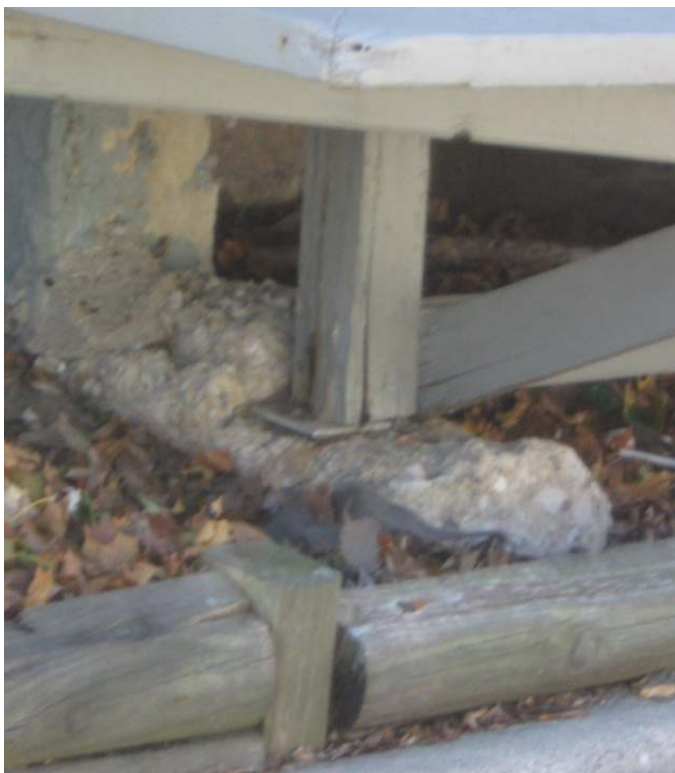
MODERATE REPAIRS ARE NEEDED FOR THE FOUNDATION WALLS AS NOTED BELOW AS CRACKING TO THE EXISTING CONCRETE FOUNDATION WALLS HAS TAKEN PLACE. THIS INCLUDES THE FOUNDATION WORK FOR THE SCREENED IN PATIO, ALL EXTERIOR AREA WELLS, AS WELL AS THE TWO ENTRY STAIRS.

Photo 3: Deterioration & Cracking at Patio Stair Concrete Foundation Walls.

In regards to the foundation walls at the (1) exterior patio location where more significant cracking has occurred, further structural analysis is advised to help determine the extent and type of repairs needed. Temporary structural shoring along with new foundation walls may be required at this location in order to prevent further structural deterioration to the floor construction above.

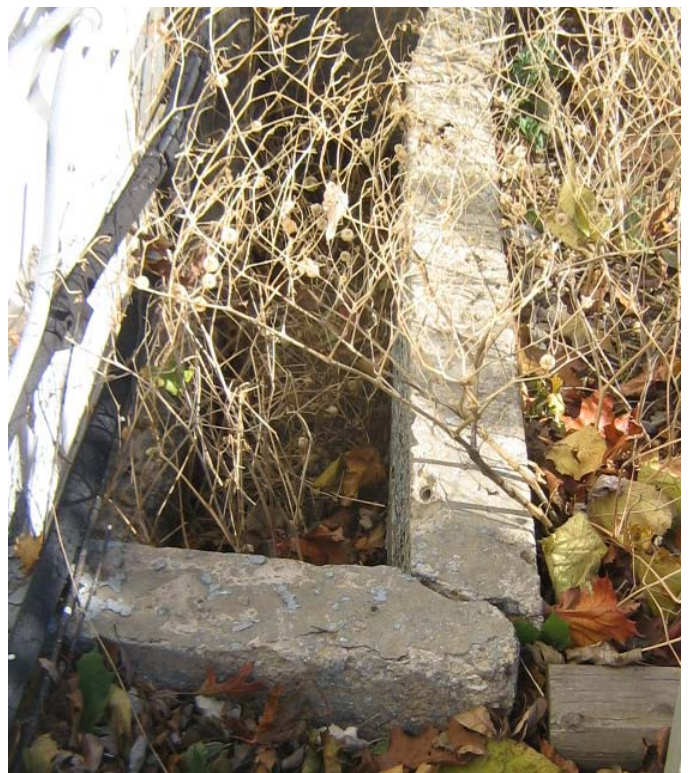
Photo 4: Deterioration & Cracking at Existing Area Well Concrete Foundation Walls.

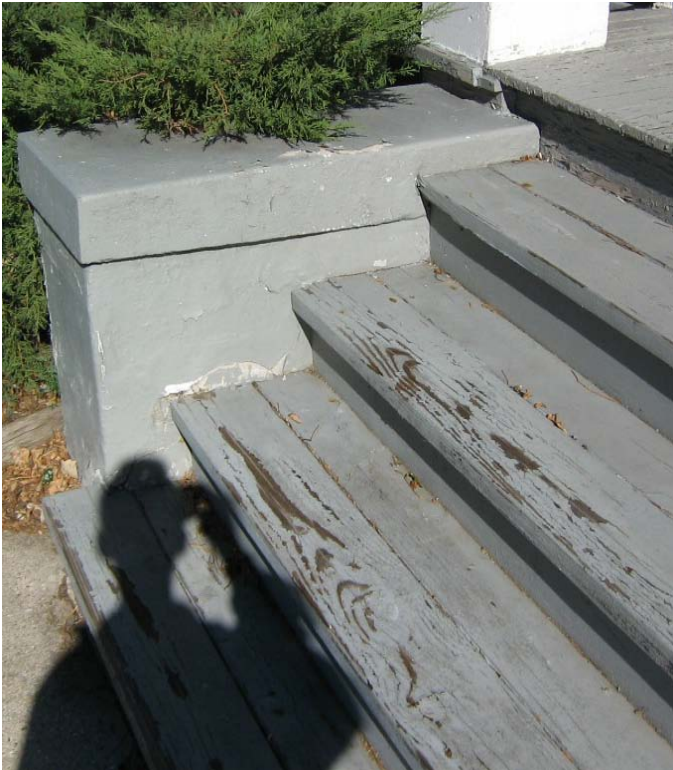
MODERATE REPAIRS ARE NEEDED FOR THE COVERED PATIO & ASSOCIATED STAIRS. DETERIORATION OF THE EXPOSED WOOD HAS TAKEN PLACE OVER TIME. IN ADDITION, THE EXTERIOR PATIO FLOOR HAS A SIGNIFICANT SAG & WARP TO IT. THE PATIO & ASSOCIATED STRUCTURE HAVE FALLEN AWAY FROM THE BUILDING ITSELF. THE ASSOCIATED FOUNDATION WORK FOR THESE PATIOS HAS CRACKED IN VARIOUS LOCATIONS. THESE ITEMS SHOULD BE ADDRESSED IN THE NEAR FUTURE TO PREVENT FURTHER STRUCTURAL DAMAGE.

Photo 5: Deterioration of Exterior Wood Stair & Associated Framing.

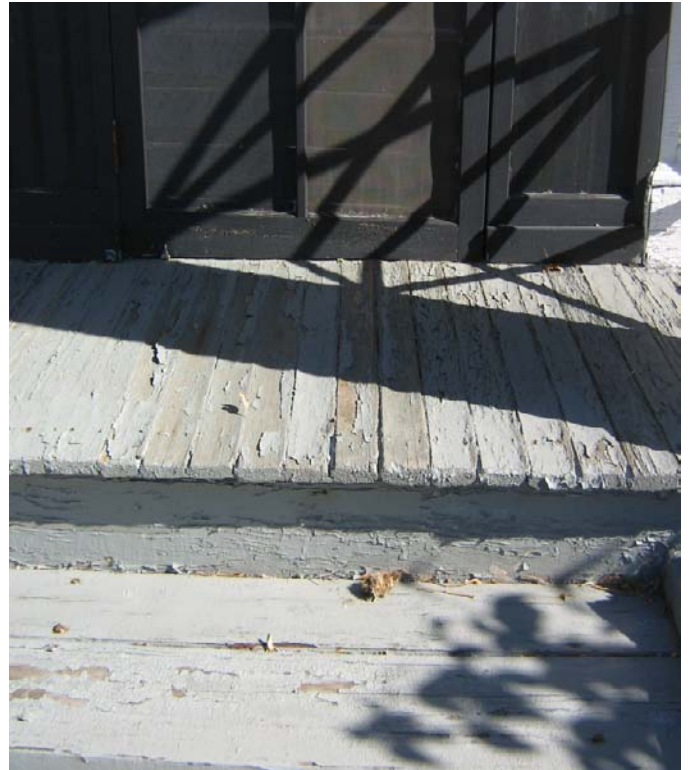
Secondly, the wood framed exterior patio has experienced significant structural deflection due to differential movement. This differential movement between patio and the building itself has caused this entire patio to begin to pull away from the rest of the building, causing significant structural sagging and additional failures to all associated floor, wall, and roof framing.

Photo 6: Deterioration of Exterior Wood Patio & Associated Wood Floor Boards.

In regards to the floor construction associated with the covered exterior patio where noticeable structural deflection differential movement has occurred, further structural analysis is advised to help determine the extent and type of repairs needed. Structural shoring & additional floor framing may be required to prevent further structural damage.

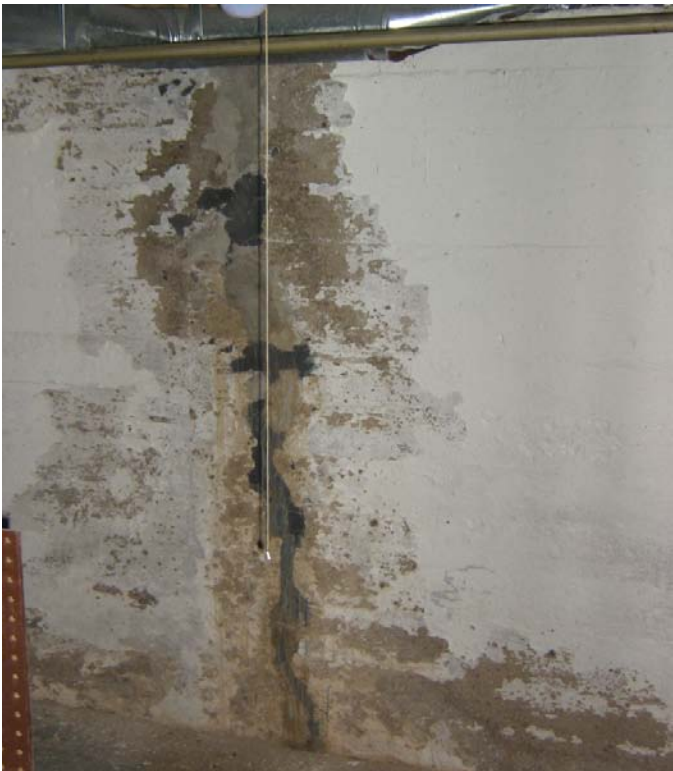
Photo 7: Deterioration & Cracking at Existing Concrete Foundation Walls.

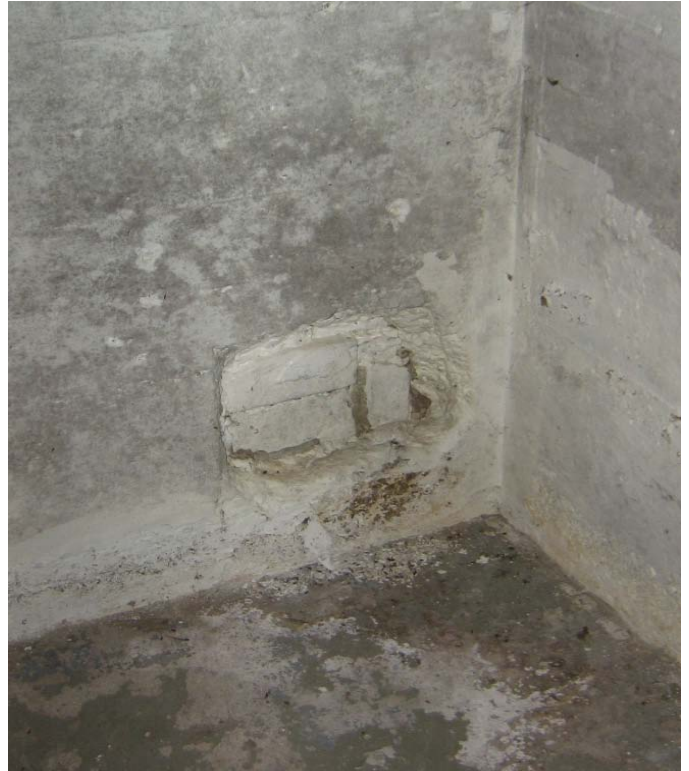
Photo 8: Deterioration & Cracking at Existing Concrete Foundation Walls.

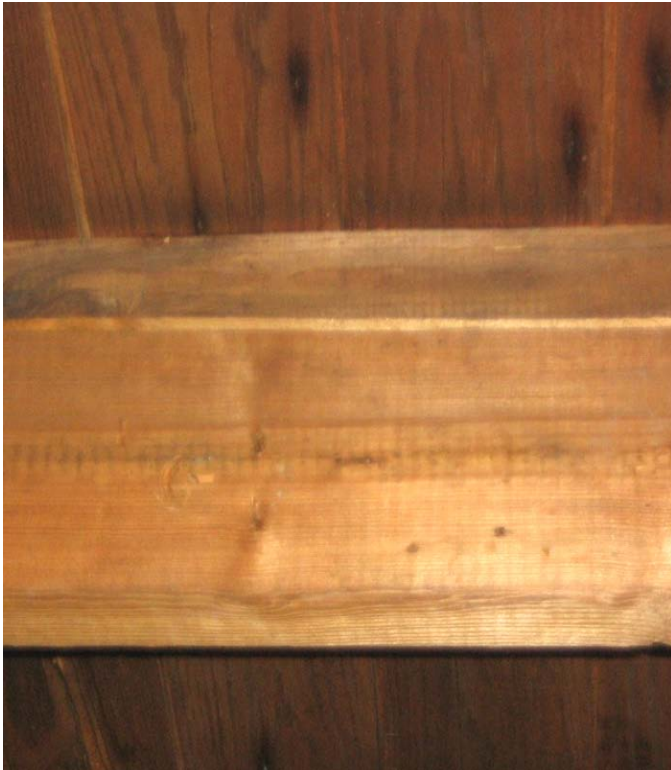
MODERATE REPAIRS ARE NEEDED FOR ROOF FRAMING AND ASSOCIATED ROOF BOARDS. MINOR DETERIORATION OF THE EXISTING ROOF FRAMING & ASSOCIATED FLOOR BOARDS WAS FOUND AS NOTED BELOW. ADVANCED STRUCTURAL DETERIORATION & SPLITTING OF THE EXISTING ROOF TRUSSES WAS FOUND AS NOTED BELOW.

Photo 9: Deterioration & Splitting of Existing Wood Roof Truss.

In general it is recommended that all exposed interior & exterior wood roof framing be cleaned and refinished to prevent further weathering and deterioration. Wood members that are structurally compromised should be replaced.

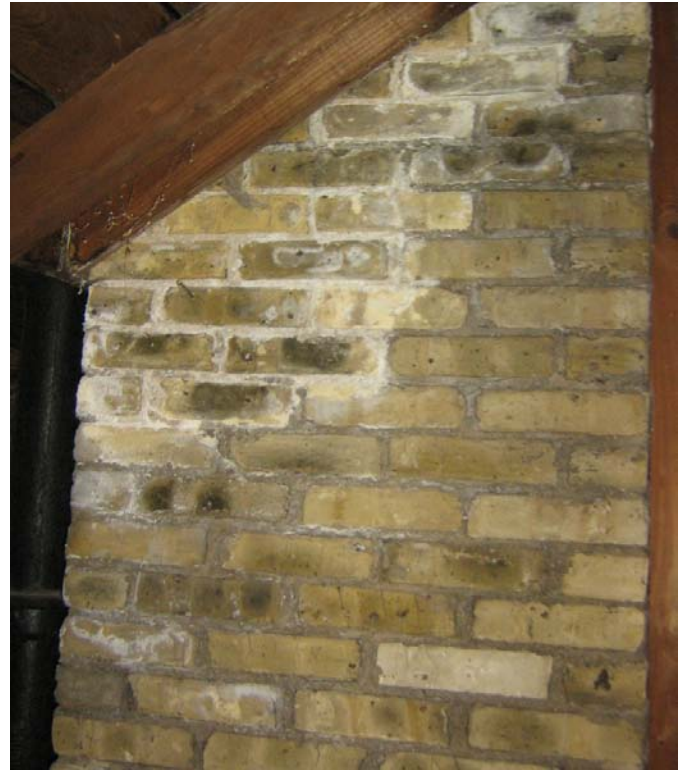
Photo 10: Deterioration of Existing Brick Chimney Stack.

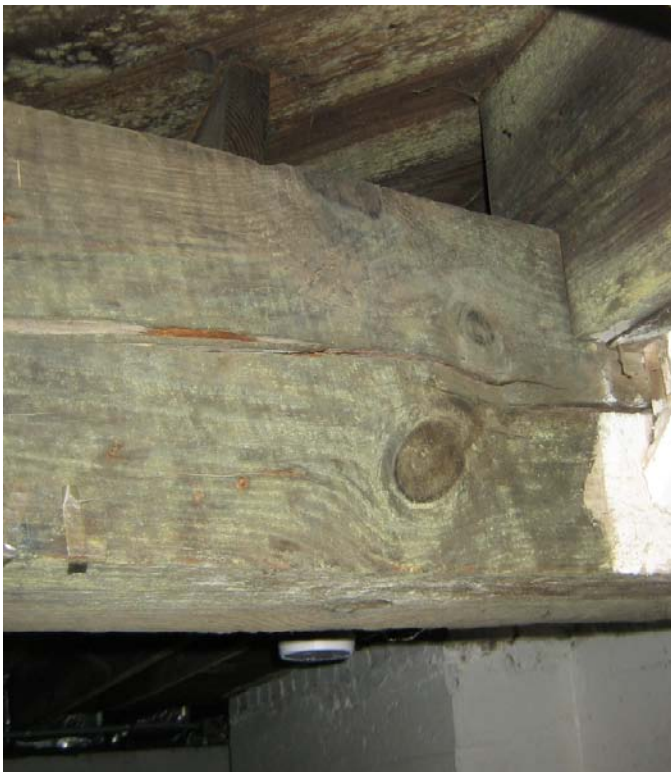
MODERATE REPAIRS ARE NEEDED FOR THE WOOD FLOOR FRAMING AS NOTED BELOW. MUCH OF THE EXPOSED WOOD FRAMING HAS UNDERGONE SEVERE DETERIORATION. ADVANCED STRUCTURAL DETERIORATION & SPLITTING OF THE EXISTING FIRST FLOOR SUPPORT BEAMS WAS FOUND AS NOTED BELOW.

Photo 11: Deterioration of Existing Wood Floor Beam & Associated Floor Framing.

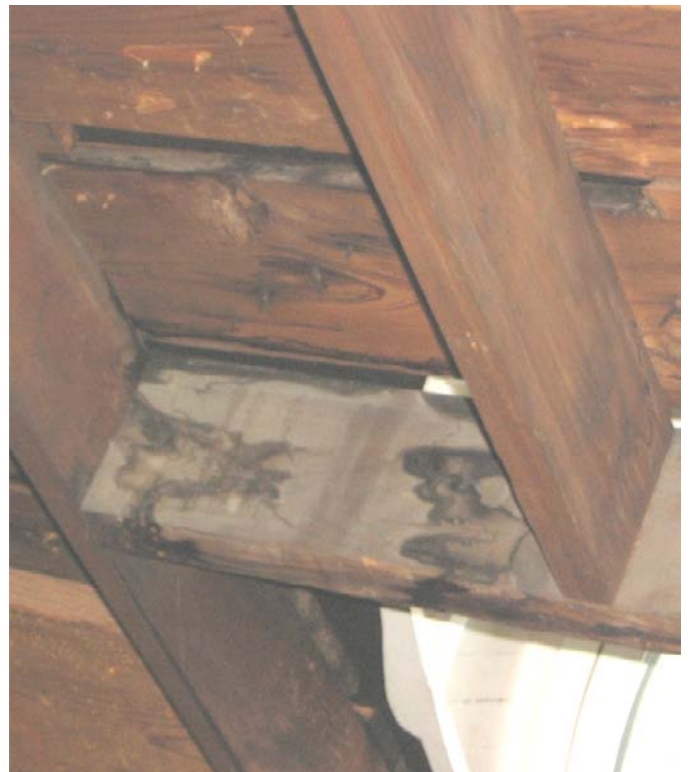
Photo 12: Deterioration of Existing Wood Roof Framing & Associated Roof Boards.

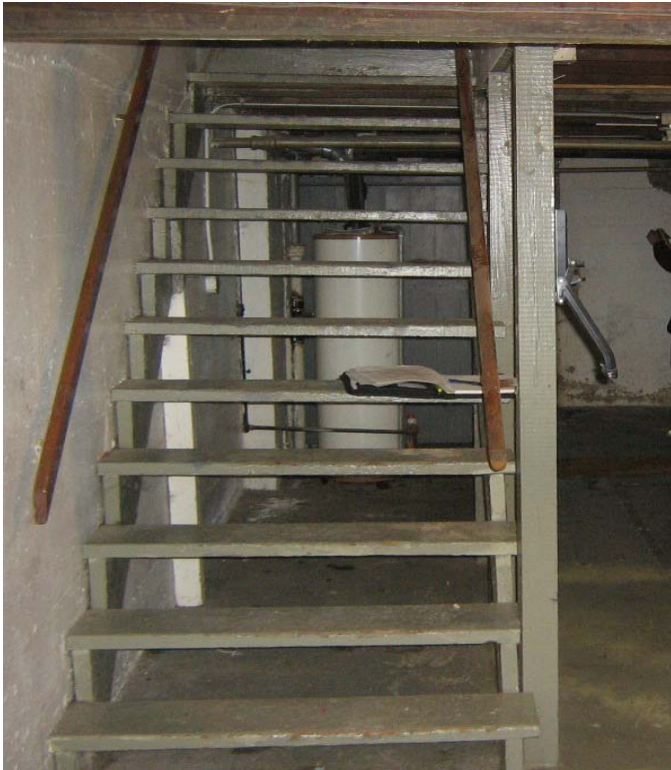
Photo 13: *Deterioration & Warping of Existing Interior Wood Stair.*

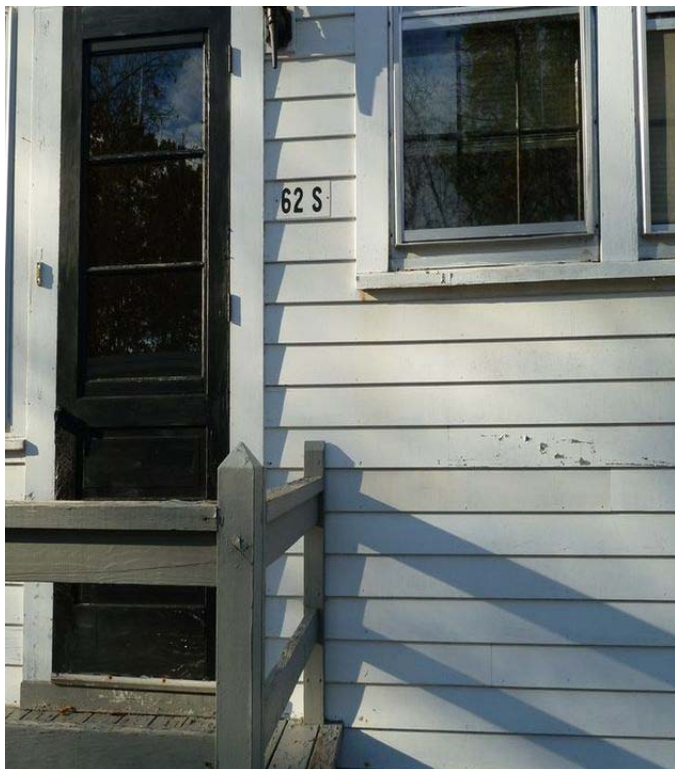
1 Peeling paint on wood clapboards, window frame, and stairs.

Paint which has begun to peel due to a failure of the bond to the wood, plaster, or metal substrate should be removed. Paint is best removed with the careful use of metal scrapers. Sanding is usually required to eliminate rough surfaces and to smooth the transition between areas of raw wood and solid original painted surfaces. Before repainting, all raw surfaces should be primed with a tested and approved primer. This treatment should then be followed by required coat(s) of paint of the type and color to match the surrounding area. All activities must be conducted in a manner consistent with the requirements provided in 29 CFR 1926.

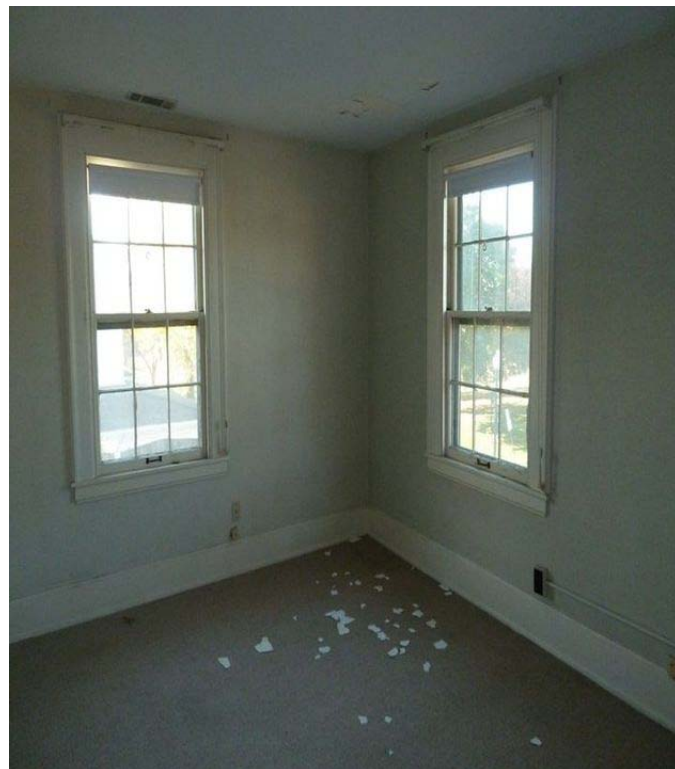
2 Cracked plaster and chipped paint.

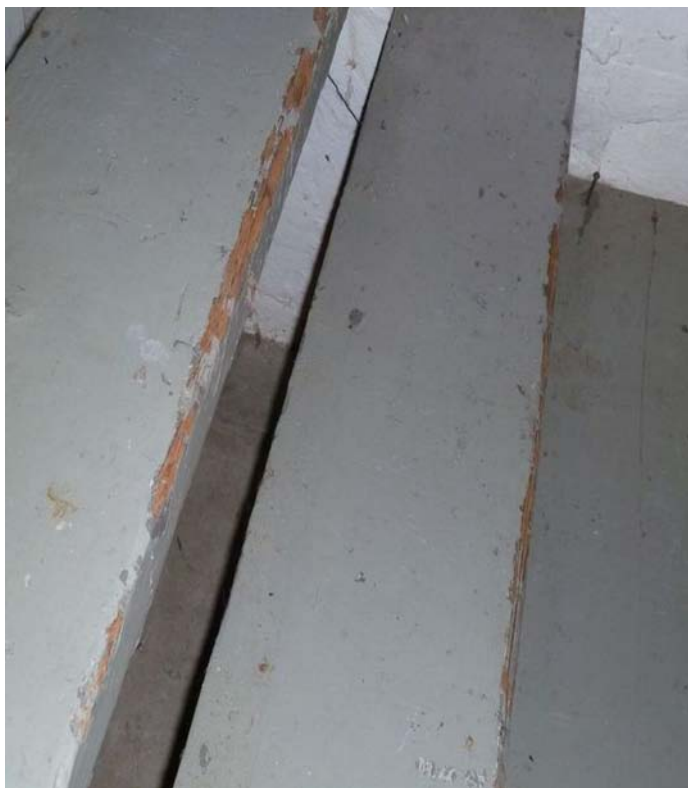
3 Peeling paint on basement stairs.

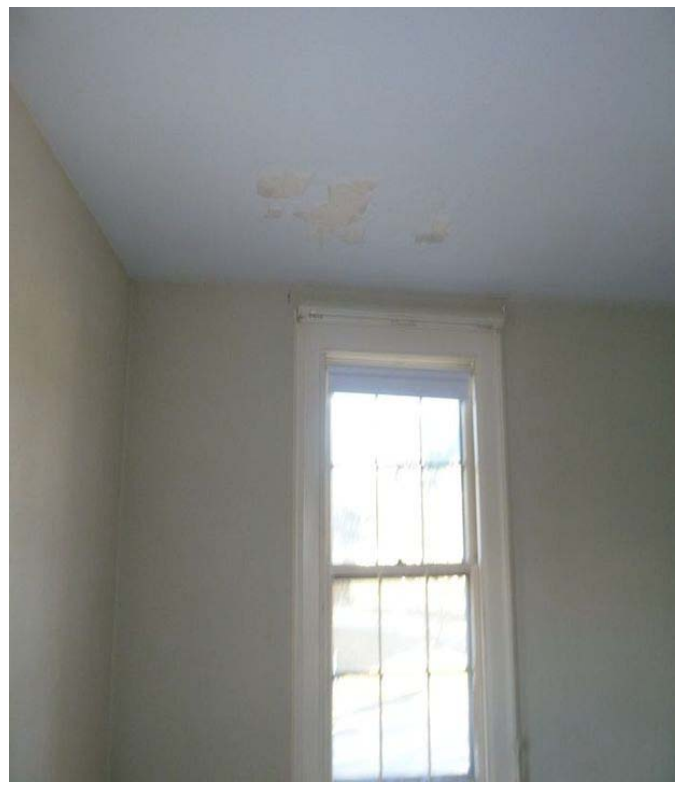
4 Peeling paint on ceiling.

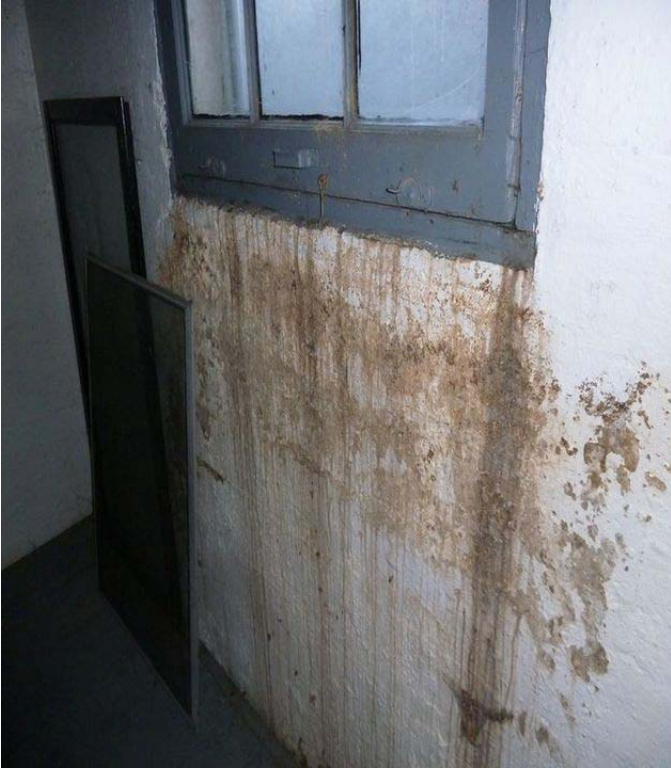
5 *Discoloration on basement wall.*

Suspect mold growth and stained building materials implies that there is or has been water intrusion or leaks or the relative humidity within the building was high enough to cause localized or widespread condensation. It is recommended that the moisture source be located and corrected, if this has not already taken place, remove fungal-impacted building materials, and replace or repair the water stained materials.

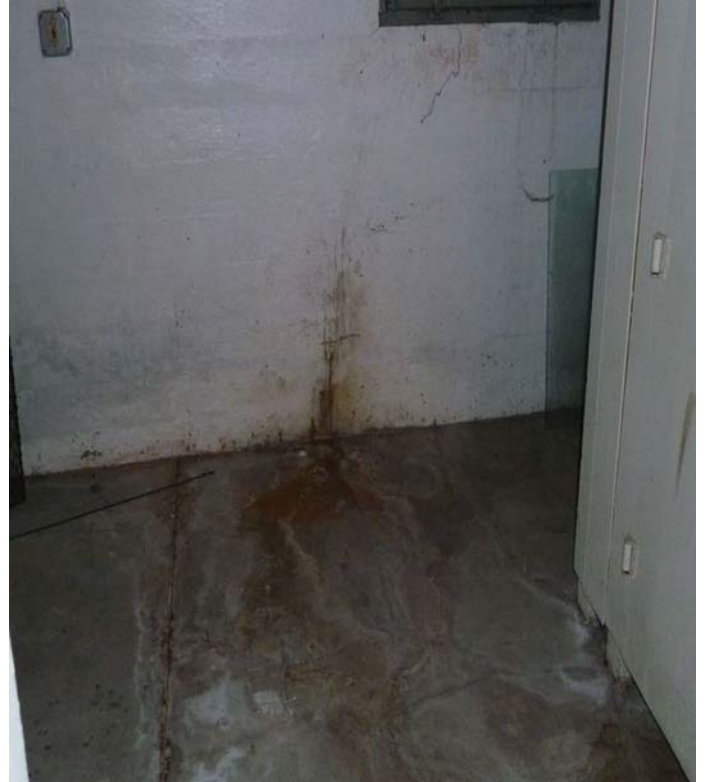
6 *Discoloration on basement wall and floor.*

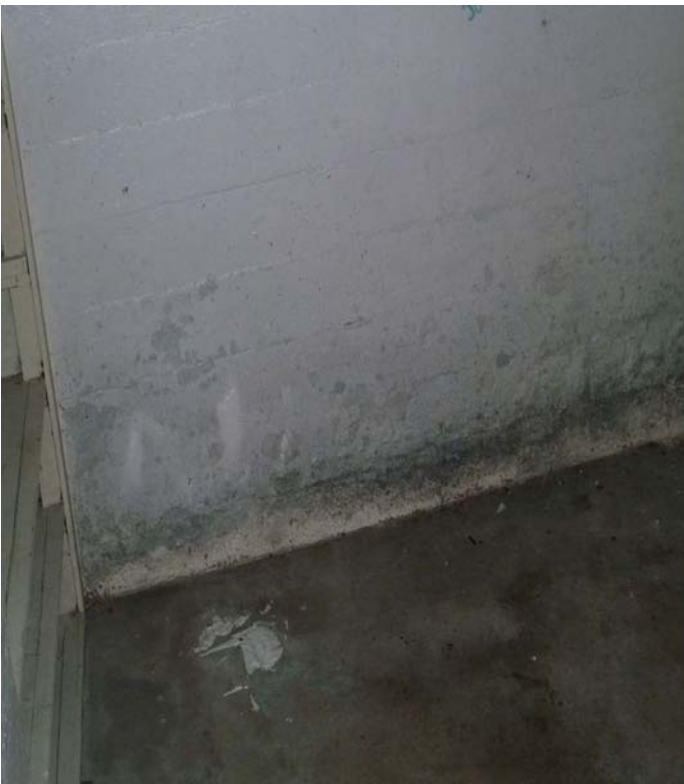
7 *Suspect mold growth on basement wall.*

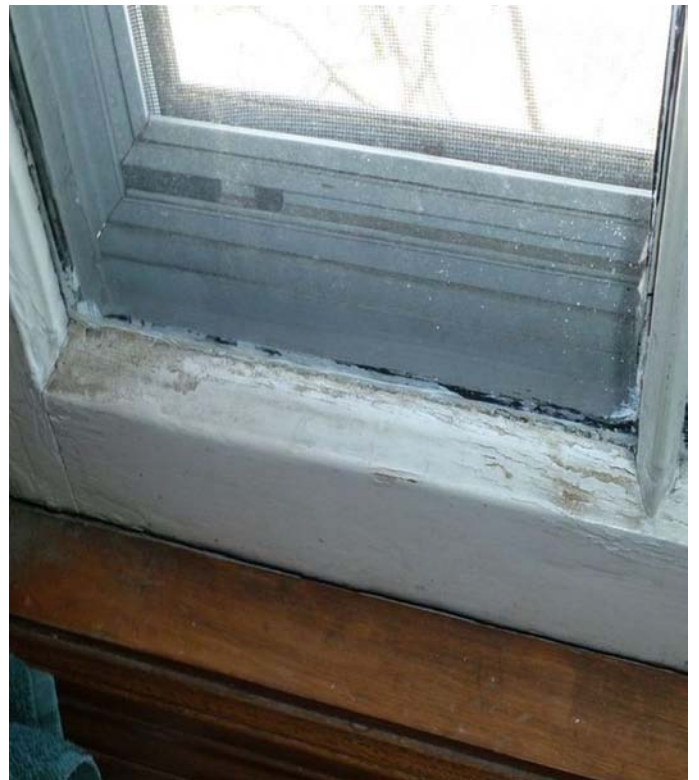
8 *Suspect mold growth on window frame.*
